case STUDY

Sterile conditioning zone now in accordance with standards at a low cost by installing a CamCleaner 600

Place: French hospital
Where: Conditioning zone for surgical equipment (sterile zone)

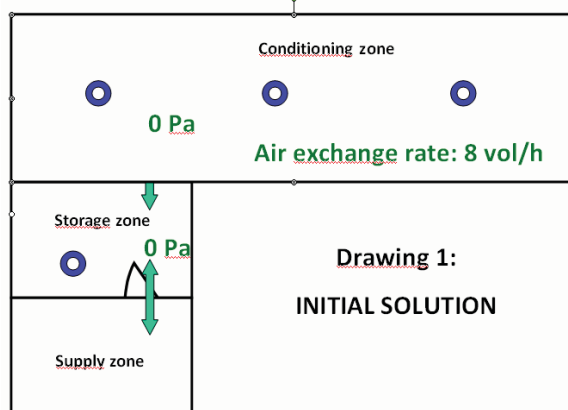
Situation (drawing 1)

Air in the conditioning zone is supplied by an AHU of 3000 m³/h.
- ISO 8 standard
- Air exchange rate: 8 vol/h
- No overpressure compared to adjacent zones

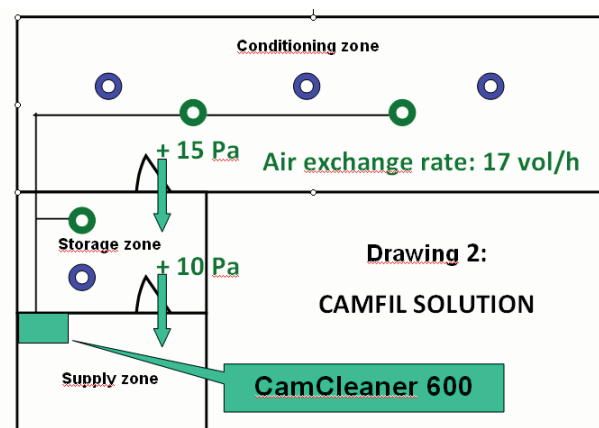
Solution (drawing 2)

Camfil supplies and installs a CamCleaner 600 in the supply zone to provide the conditioning zone with:
. A higher air exchange rate
. An overpressure

The Camcleaner extracts 6000 m³/h from the supply zone, the air goes through two air filtration stages, one F5 the other F6:
. 4000 m³/h are sent into the conditioning zone (in addition to the 3000 m³/h from the existing AHU)
. 2000 m³/h are sent into the storage zone.
The result is an air exchange rate of 17 vol/h
The conditioning zone is still ISO 8 and is in overpressure with regards to the storage zone, itself being in overpressure with regards to the supply zone.
