case STUDY

HOSPITAL

Sterile conditioning zone now in accordance with standards at a low cost by installing a CamCleaner 600

Place: French hospital
Where: Conditioning zone for surgical equipment (sterile zone)

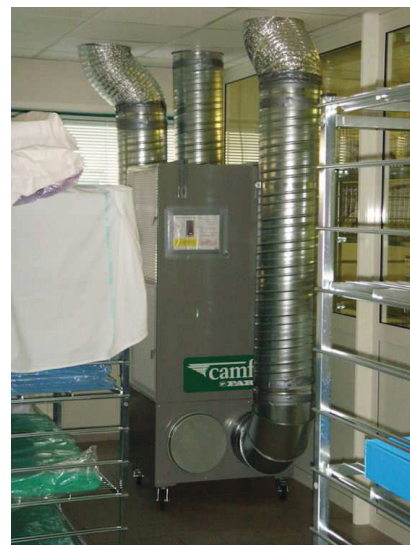
Situation (drawing 1)

Air in the conditioning zone is supplied by an AHU of 3000 m³/h.
 - ISO 8 standard
 - Air exchange rate: 8 vol/h
 - No overpressure compared to adjacent zones

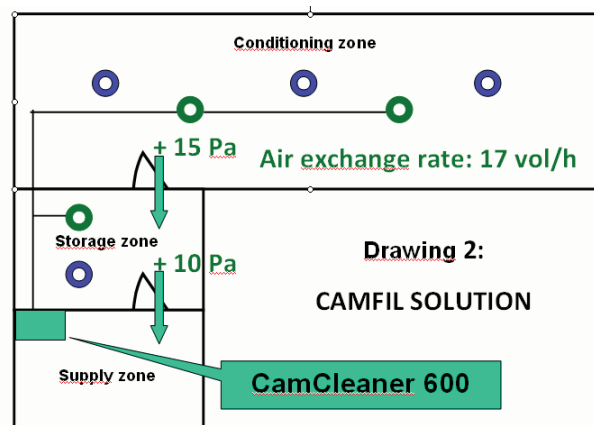
Solution (drawing 2)

Camfil supplies and installs a CamCleaner 600 in the supply zone to provide the conditioning zone with:
 . A higher air exchange rate
 . An overpressure

The Camcleaner extracts 6000 m³/h from the supply zone, the air goes through two air filtration stages, one F5 the other F6:
 . 4000 m³/h are sent into the conditioning zone (in addition to the 3000 m³/h from the existing AHU)
 . 2000 m³/h are sent into the storage zone.
 The result is an air exchange rate of 17 vol/h
 The conditioning zone is still ISO 8 and is in overpressure with regards to the storage zone, itself being in overpressure with regards to the supply zone.
